**Yukon Agricultural Association**  
**Bid Package**  
**Sale: John Deere 1590 Disk Drill**  
**SN: N01590X731131**

## Inspection Report July 2024

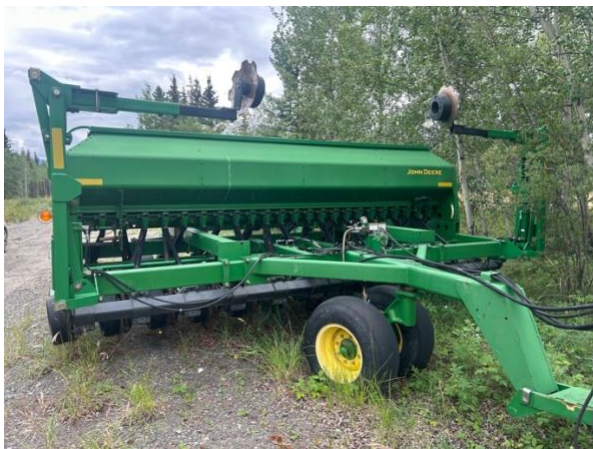
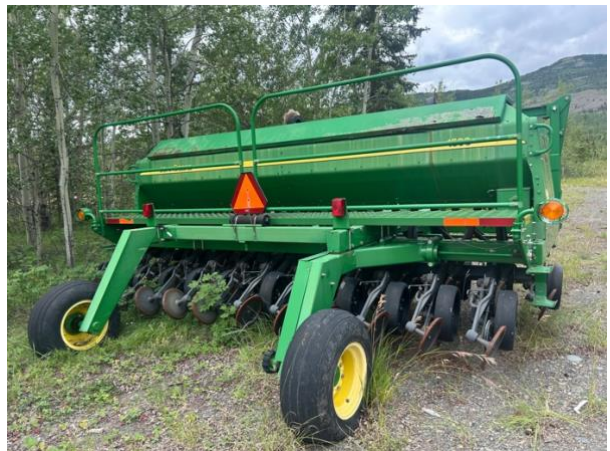
- Safety chain needs proper connection hook
- Front caster tires - replacement required
- Both rear tires - replacement required

- All metering chains require adjustment or replacement.
- All chain idlers worn out
  - this will affect seed and fertilizer application rates
- Fertilizer transmission adjusters seized.

- Can be repaired through disassembly of gearbox and cleaning
- Left rear wheel seal leaking
- Repack all wheel bearings
- Ground drive clutch hub loose on shaft.

- Overhaul clutch as required.
- Fertilizer floor damaged.
  - Rust degradation.
- Fertilizer lid damaged.
  - Rust degradation.
- Fertilizer trough damaged.

- Rust degradation.
- Openers require regular maintenance.
- All Seed boot seals need replaced/repairs.
- 8 Large packer wheels bent.
  - This is typically caused by leaving the drill in the ground while turning at the headland.

- 5 small packer wheel bushings have excessive play.
  - Normal wear, but does allow small packer wheel to drift off of row.
- Seed meter adjustment almost seized from being in the weather.

- Uneven wear will occur as well as affect seed/fertilizer to soil compaction.
  - Recommend seeding back and forth and finishing with the headland to remedy.

- Recommendation to use a heavier oil or diesel fuel to protect against rust.
